BGA Reliability and Manufacturing Challenges

Dr. Nathan Blattau

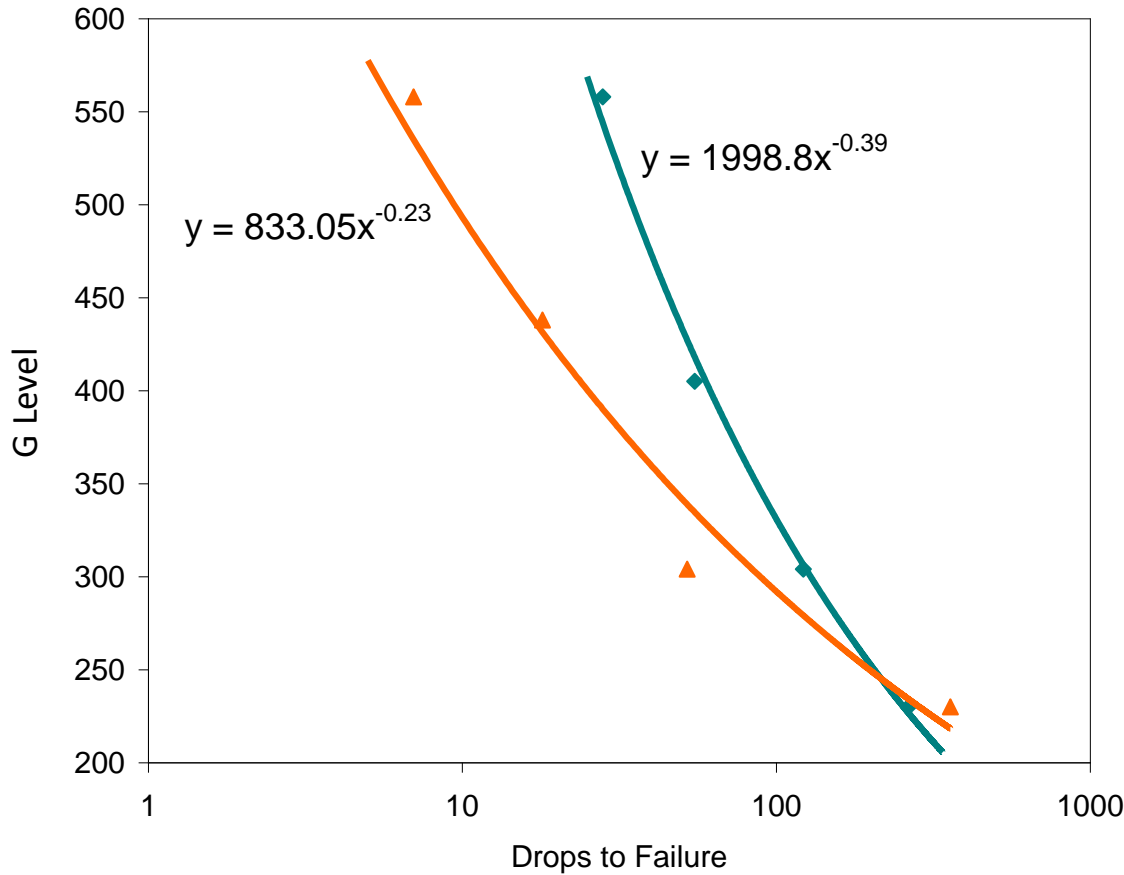
- ▶ Significant improvement in drops to failure at higher shock loads

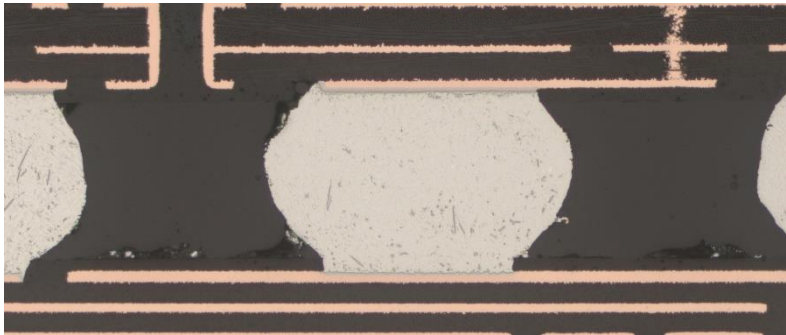
- ▶ During reflow the substrate of the BGA will expand more than the die and overmold portion causing the corners to bend upward
- ▶ This can lift the solder ball high enough that it isn't in contact with the solder paste during reflow
- ▶ One good indicator is the presence of solder joints that appear stretched and other that appear compressed
- ▶ Possible causes
 - Reflow profile
 - Moisture in the package

Package Center

Package Corner
